## TEST REPORT

No. : GZMR250401125101

CUSTOMER NAME: UDC Mower Parts LLC  
ADDRESS: 3524 SILVERSIDE ROAD SUITE 35B

Sample Name : Mower Belts  
Product or Lot No. : 405143

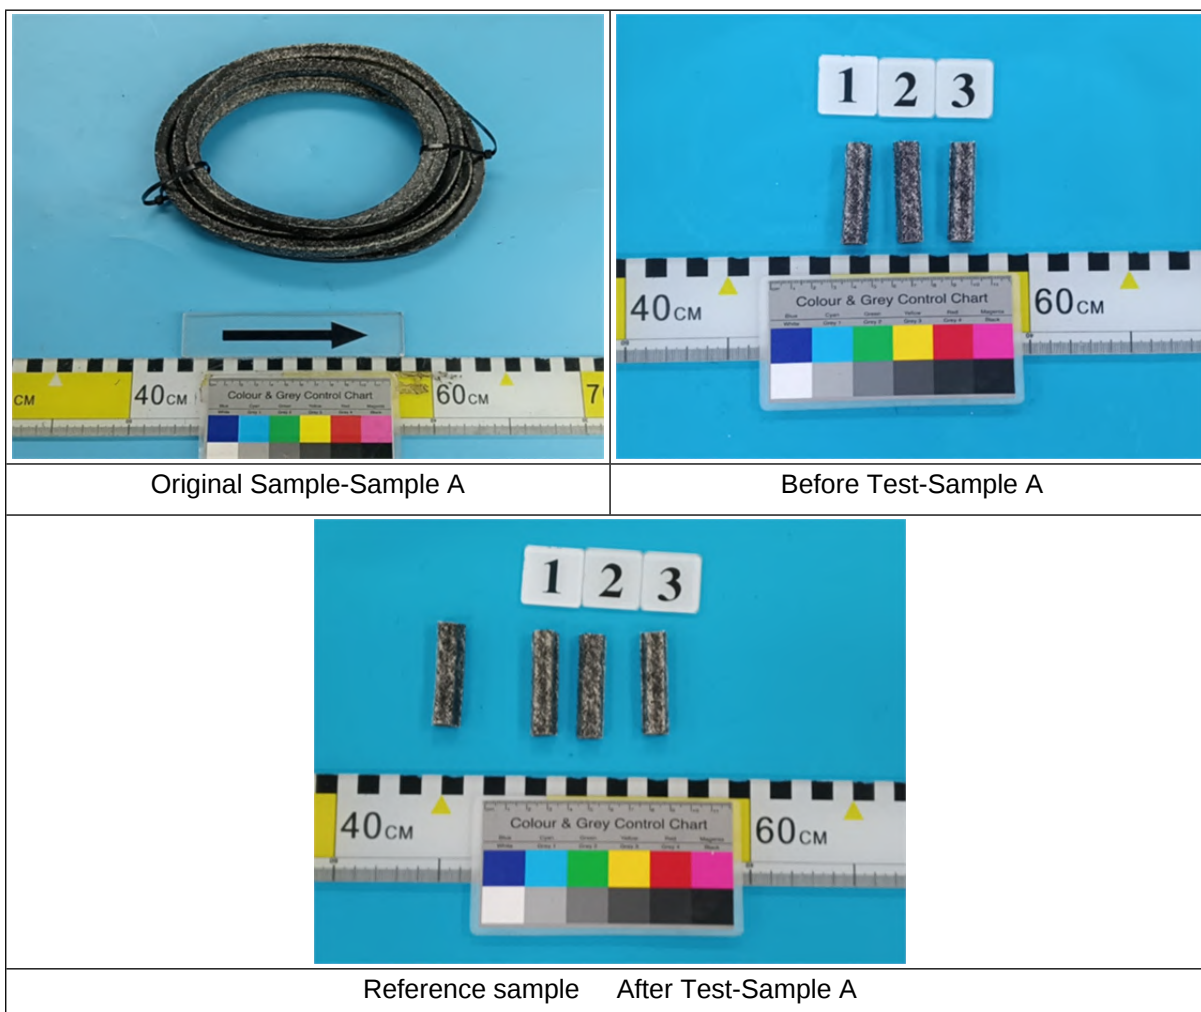
Test Photo:

Test Condition:

Heat ageing condition: 100℃,48h→Take out and check appearance

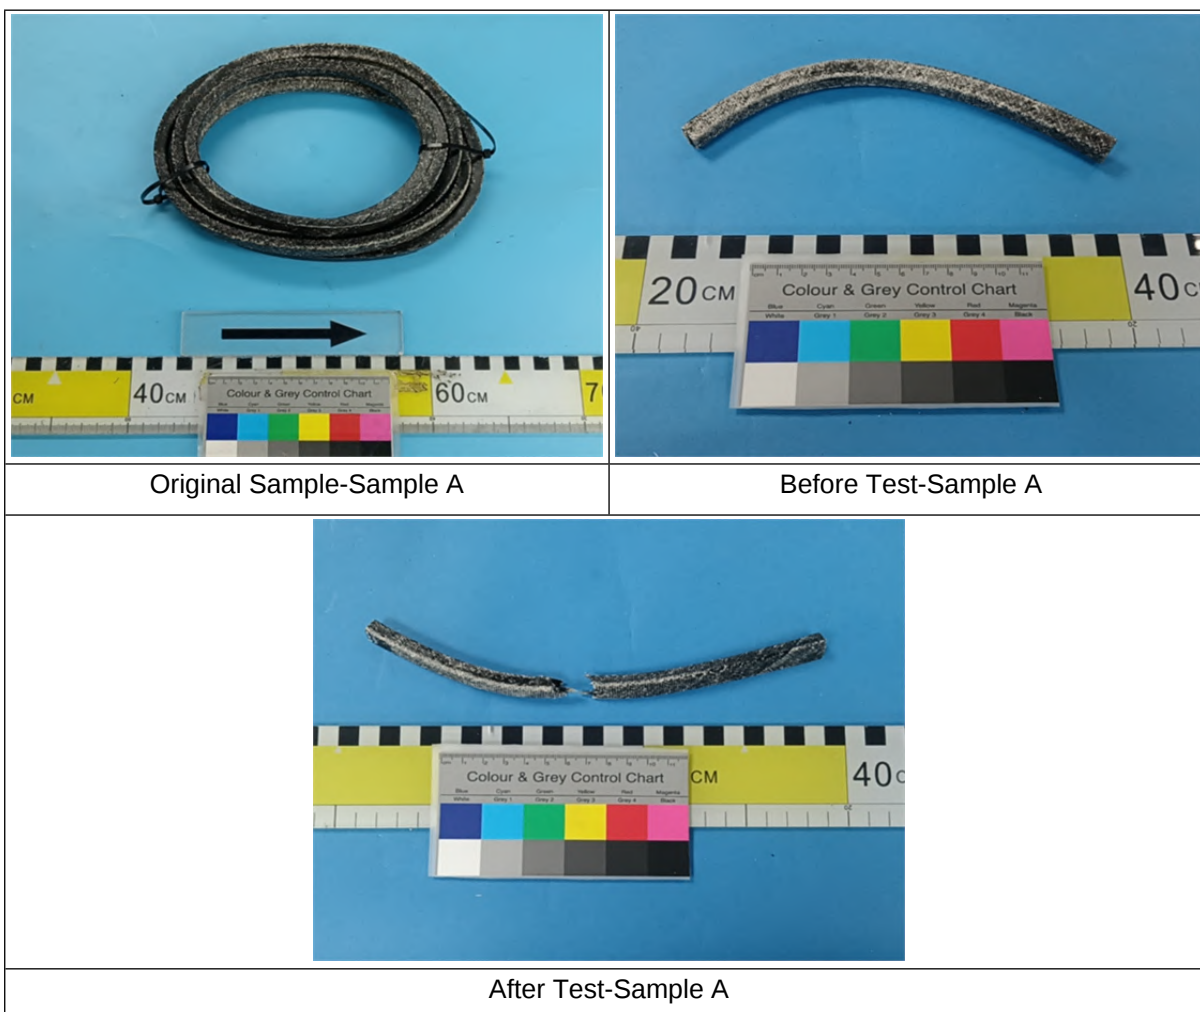
Test Photo:

Test Condition:

Lab Environmental Condition: ( 23 ± 2 ) °C, ( 50 ± 5 ) %RH

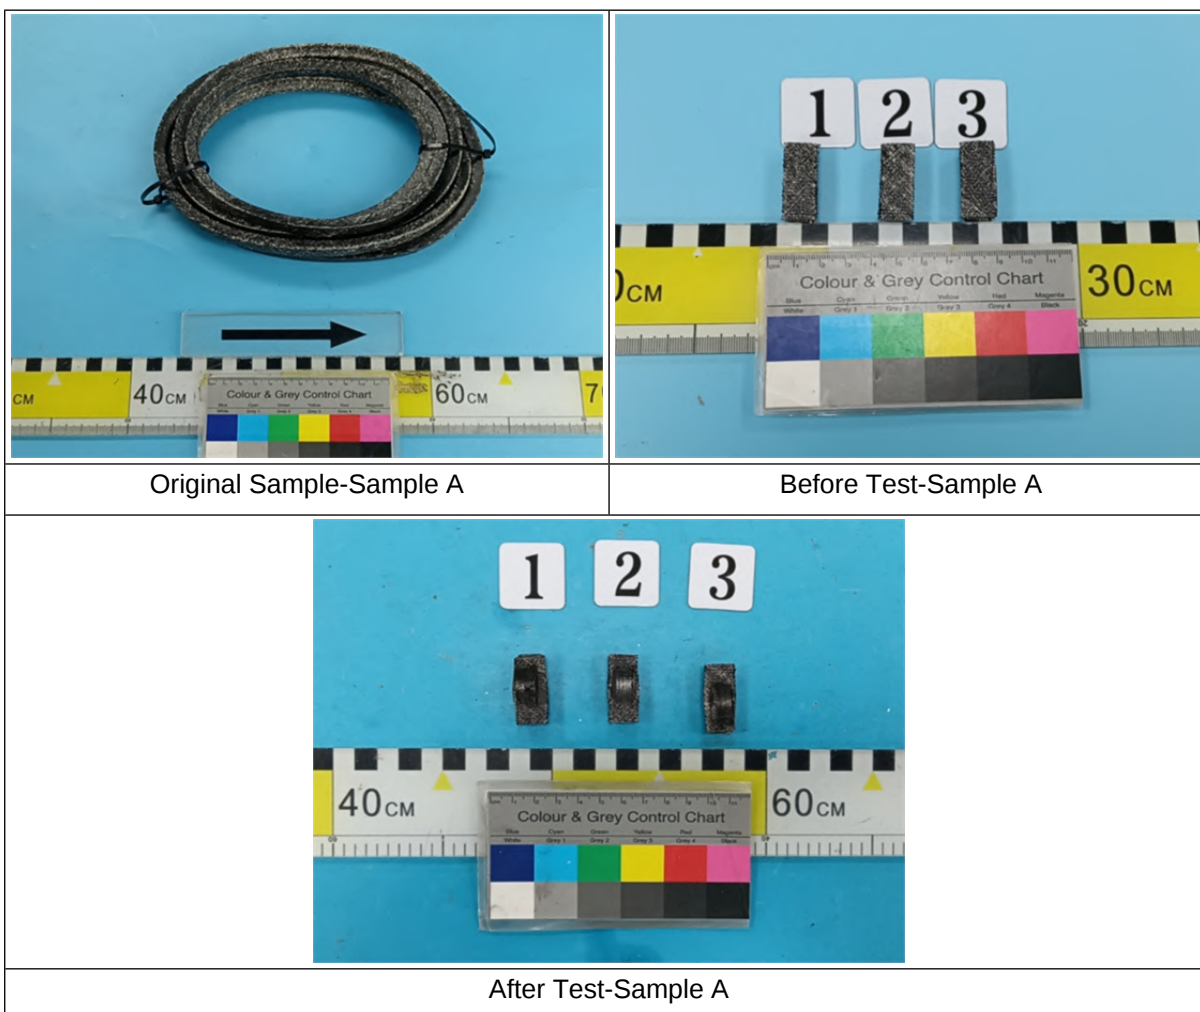
Test Photo:

### 3. Test Item: Sliding Friction and Wear

| Test Item | Test Result |
|---|---|
| Wear Volume | 0.0231cm <sup>3</sup> |
| Wear Mass | 0.0292g |
| Wear Width | 15.5mm |

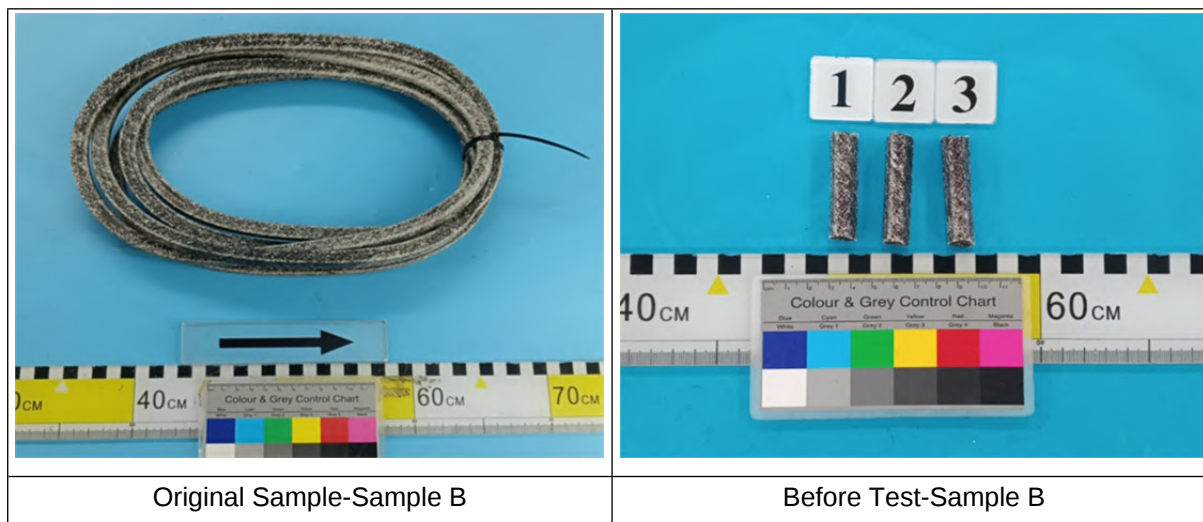
Test Photo:

Heat ageing condition: 100℃,48h→Take out and check appearance

Note: Test specimens were cut from the sample.

Original Sample-Sample B

Before Test-Sample B

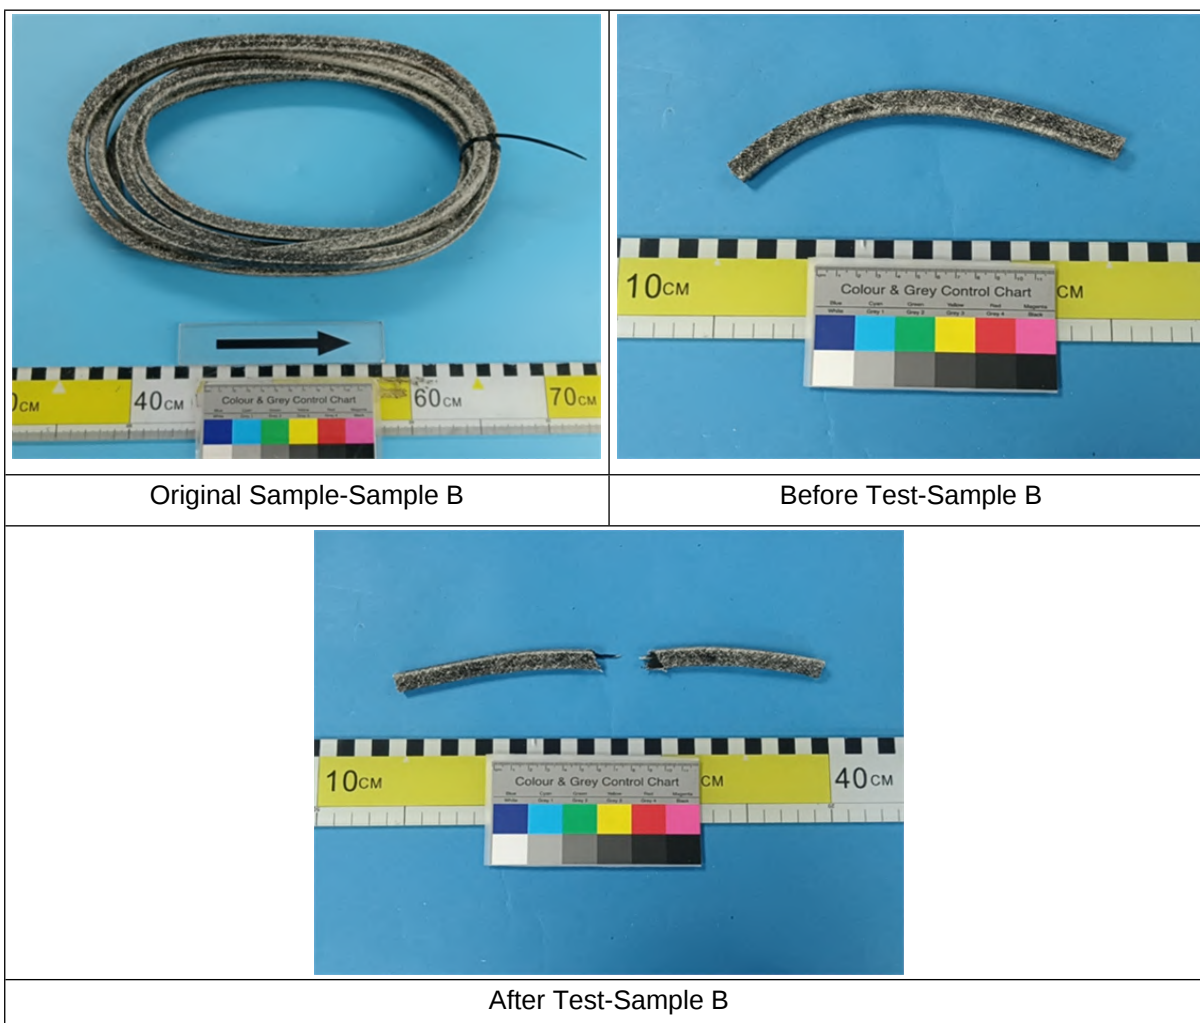
Test Photo:

Test Condition:

Lab Environmental Condition: ( 23 ± 2 ) °C, ( 50 ± 5 ) %RH

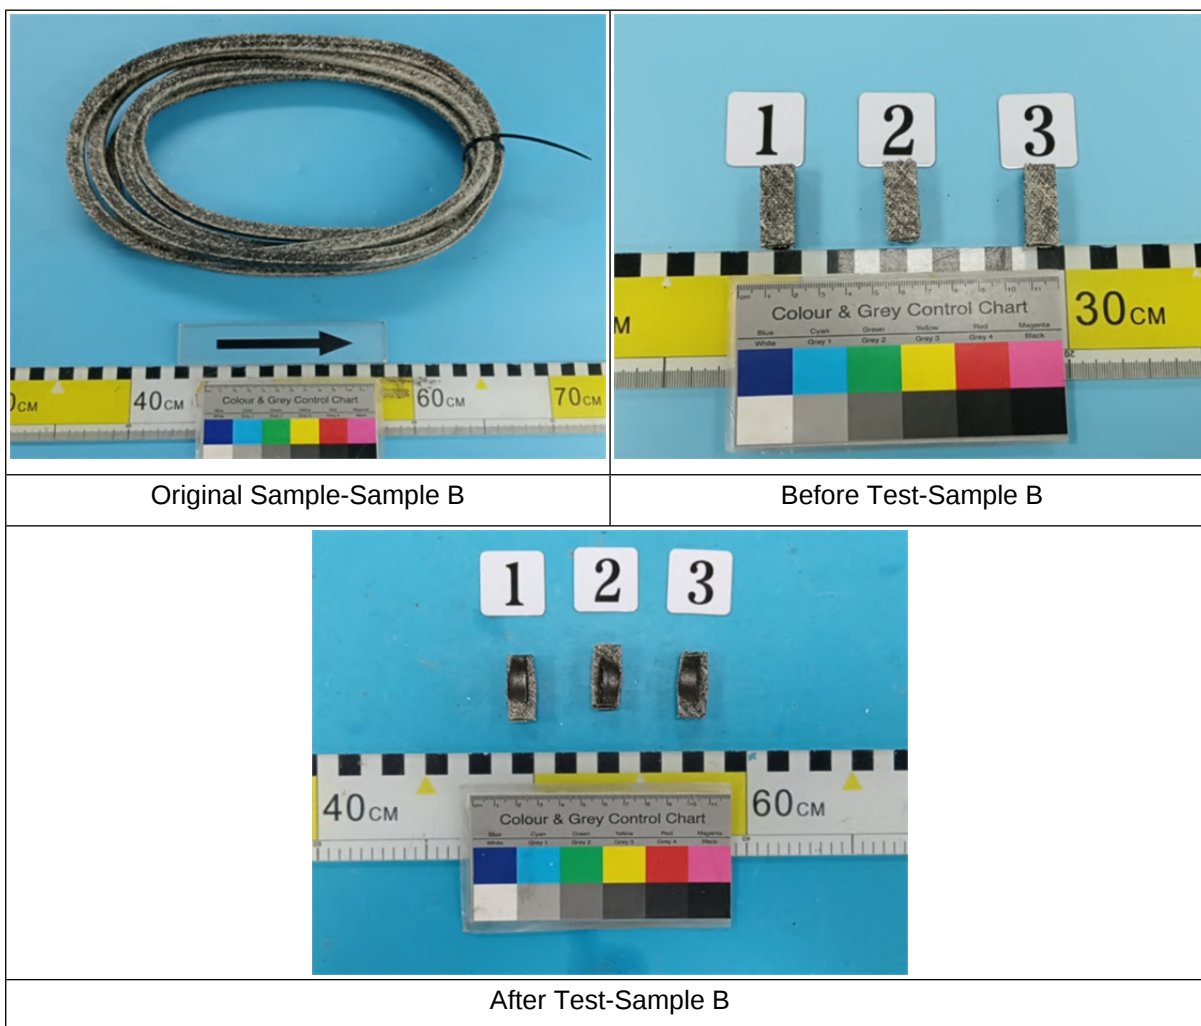
Test Photo:

### 3. Test Item: Sliding Friction and Wear

| Test Item | Test Result |
|---|---|
| Wear Volume | 0.0224cm <sup>3</sup> |
| Wear Mass | 0.0281g |
| Wear Width | 18.2mm |

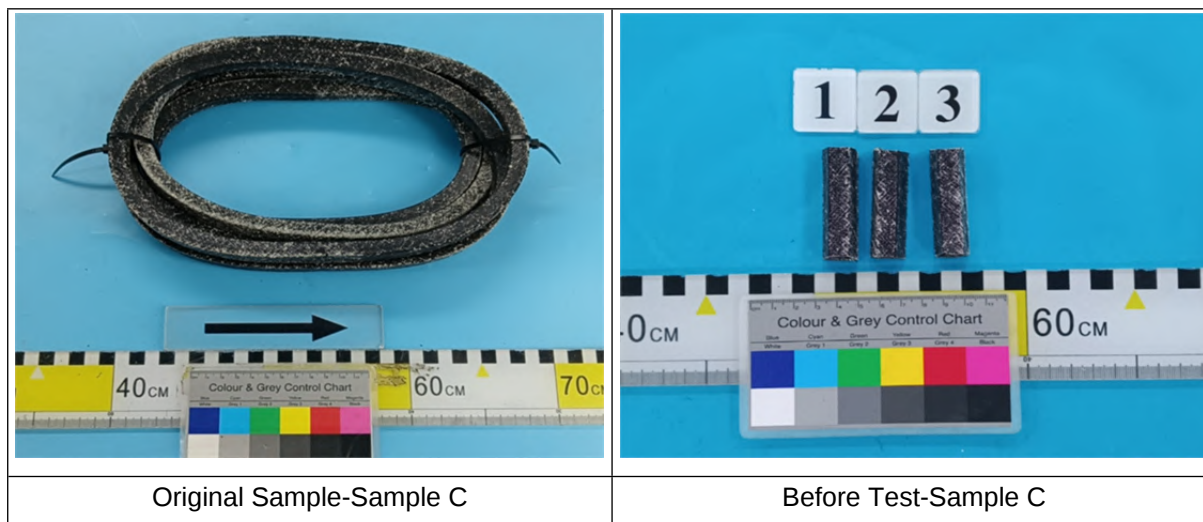
Test Photo:

Heat ageing condition: 100℃,48h→Take out and check appearance

Note: Test specimens were cut from the sample.

Original Sample-Sample C Before Test-Sample C

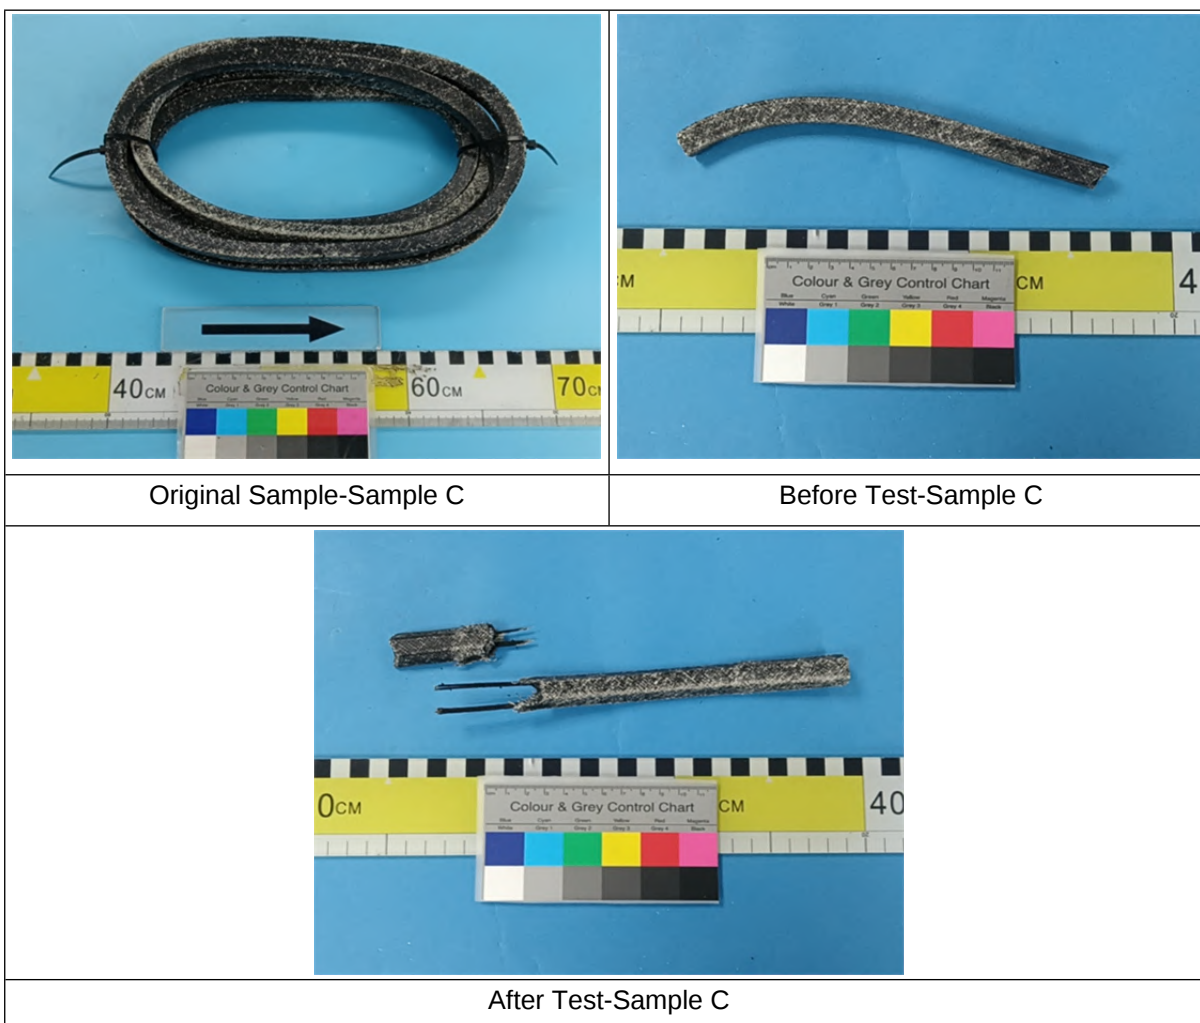
Test Photo:

Test Condition:

Lab Environmental Condition: ( 23 ± 2 ) °C, ( 50 ± 5 ) %RH

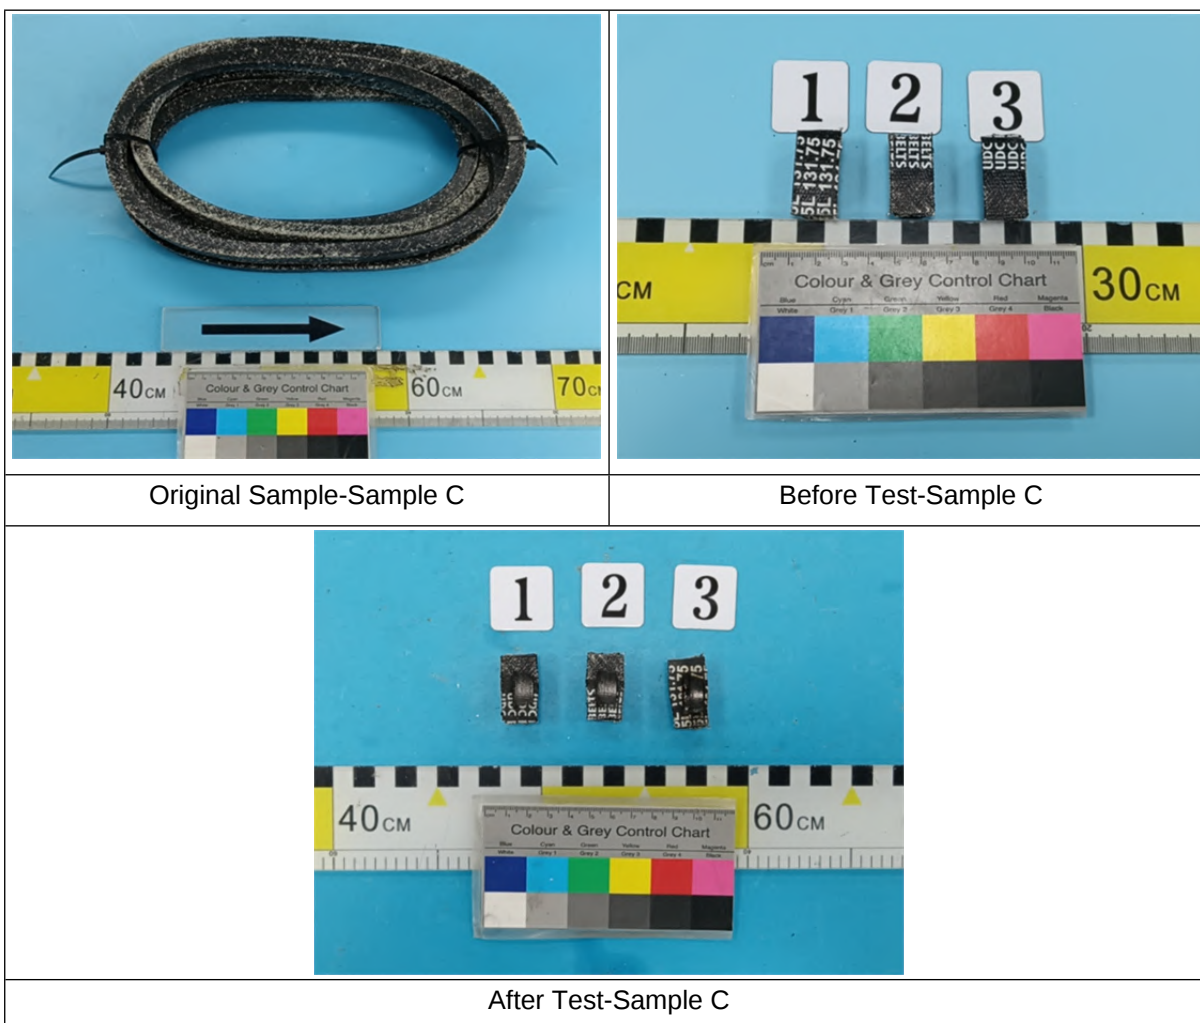
Test Photo:

### 3. Test Item: Sliding Friction and Wear

| Test Item | Test Result |
|---|---|
| Wear Volume | 0.0370cm <sup>3</sup> |
| Wear Mass | 0.0476g |
| Wear Width | 15.0mm |
